Manhole Inspection Summary

Manhole # S37QQ_018MH

Insp Date: **4/4/07 9:17 AM**

Location Address: **518 25TH ST**

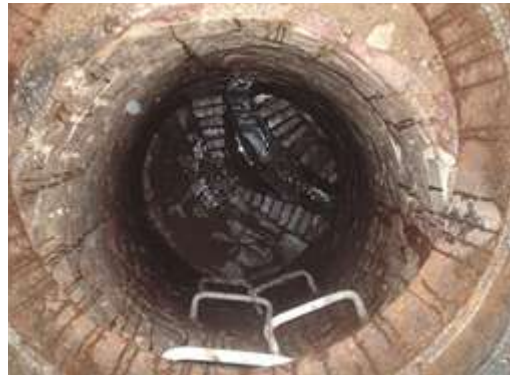
Top View

Corroded steps. Evidence of surcharge - Bench debris. Channel debris.

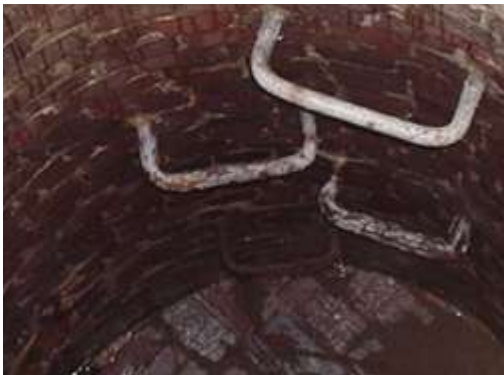
Defect

Corroded steps. Barrel infiltration.

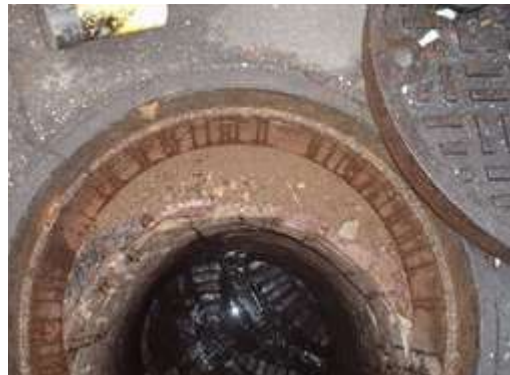
Defect

Frame offset. Corbel infiltration.

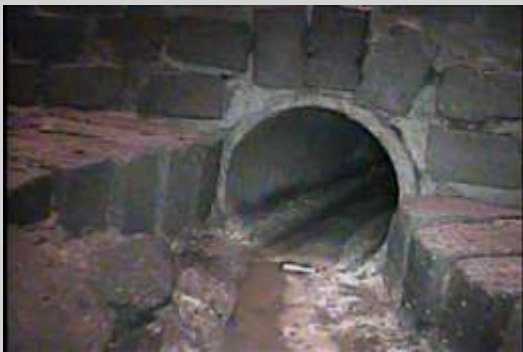
8 in. Circular Gravity Sewer Pipe Out @ 12 O'Clock

Deposits: ☐ None ☐ Mud ☐ Sludge ☐ Debris ☒ Grease

Silt Depth: **0** (in.) Deposits Extent: **Light**

Infiltration: **Evidence** Pipe Seal Cond: **Unknown**

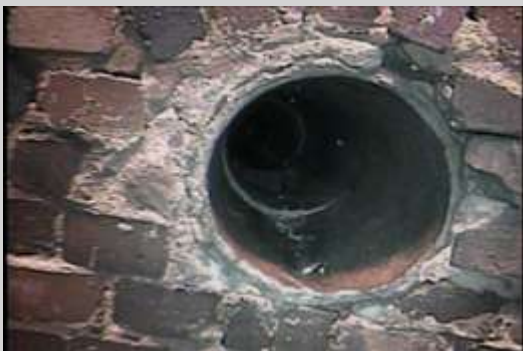
8 in. Circular Gravity Sewer Pipe In @ 3 O'Clock

Deposits: ☒ None ☐ Mud ☐ Sludge ☐ Debris ☐ Grease

Infiltration: **None** Pipe Seal Cond: **Sound**

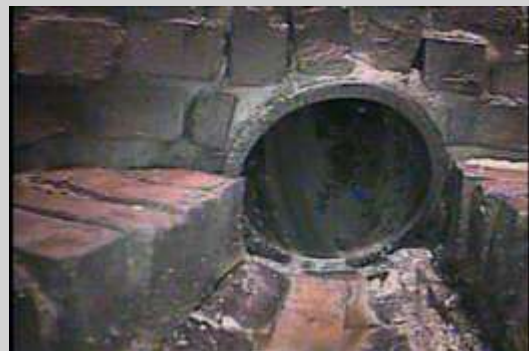
Drop In @ 3 O'Clock

Drop: **Outside** Rod and Bar

Drop Condition: **Open**

Connects To: **Dead End**
